NAUGATUCK RIVER BASIN
OXFORD, CONNECTICUT

SWAN LAKE DAM
CT 00328

PHASE I INSPECTION REPORT
NATIONAL DAM INSPECTION PROGRAM

SEPTEMBER 1980

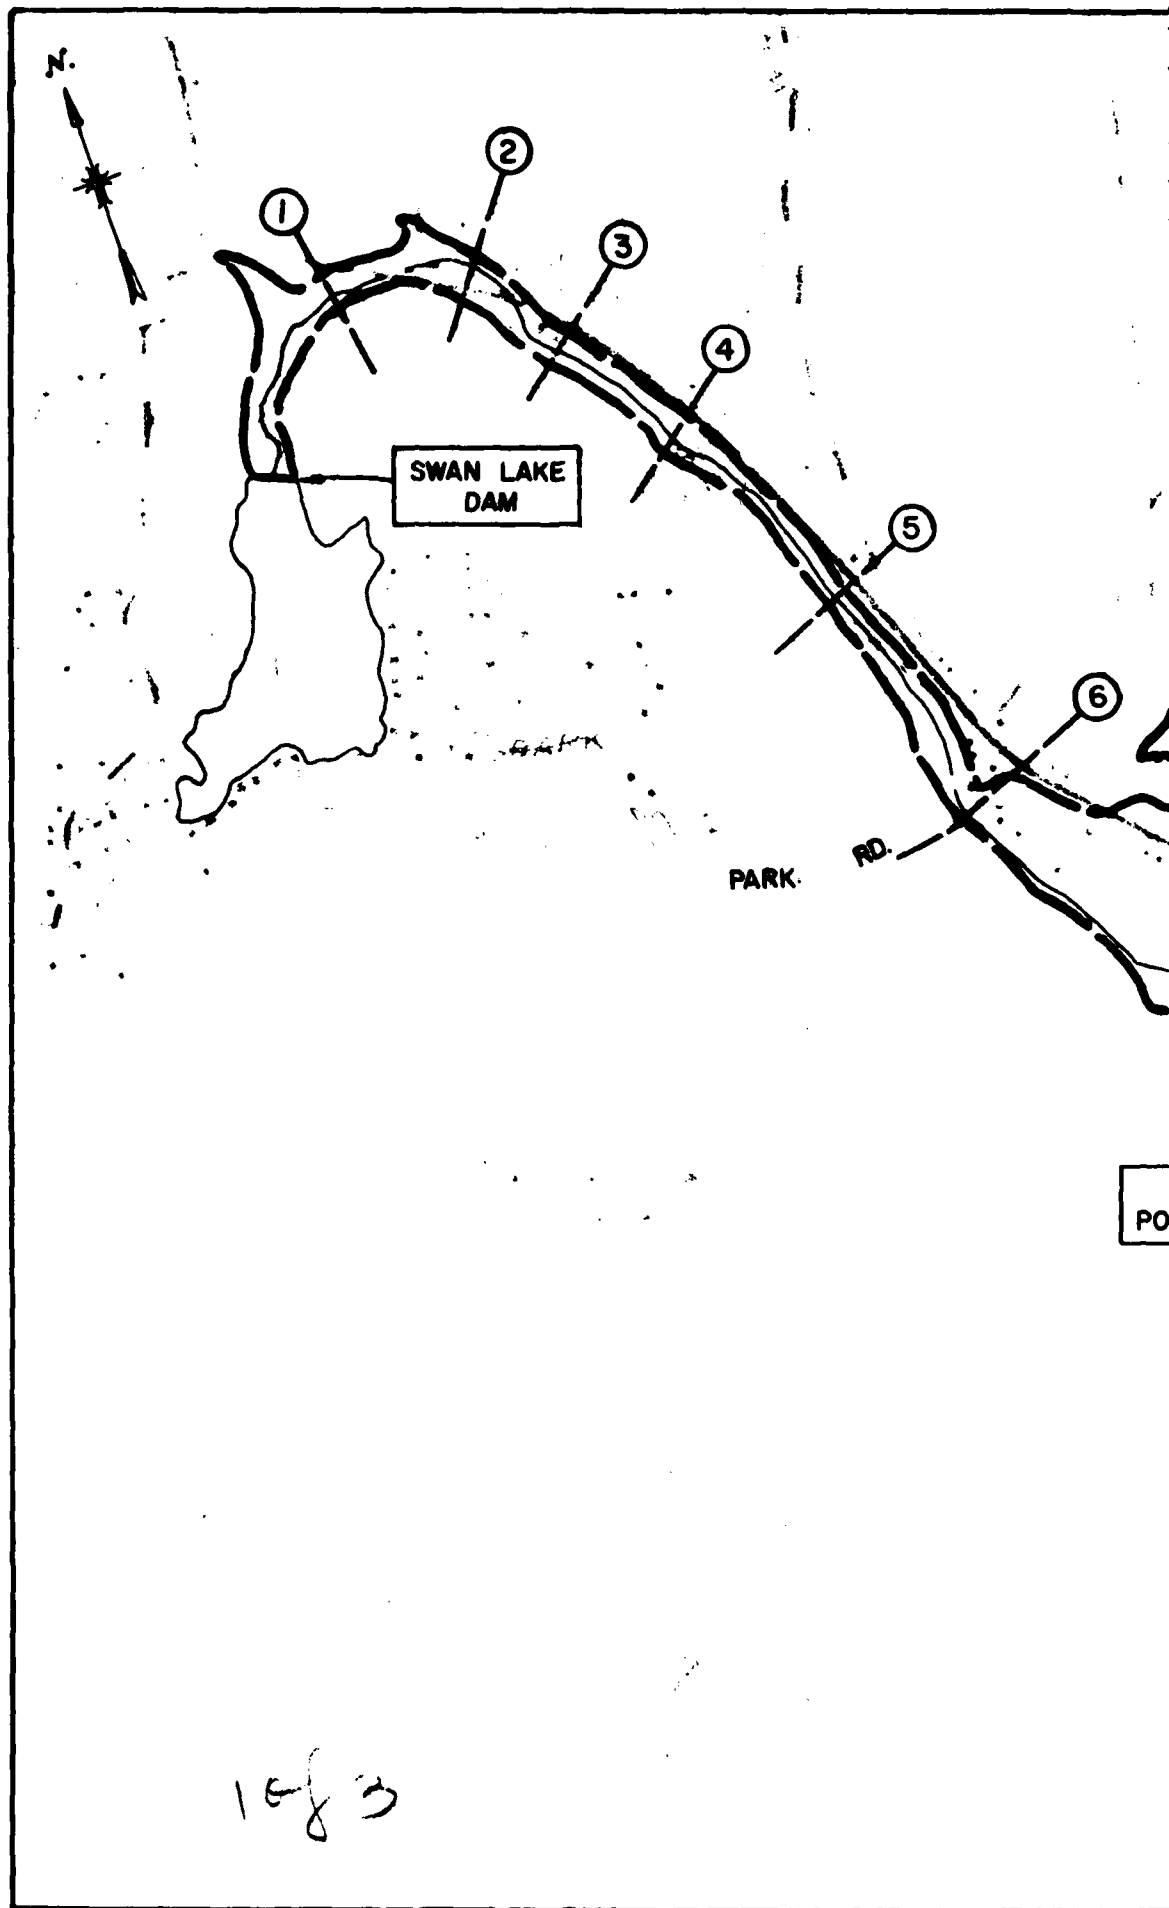
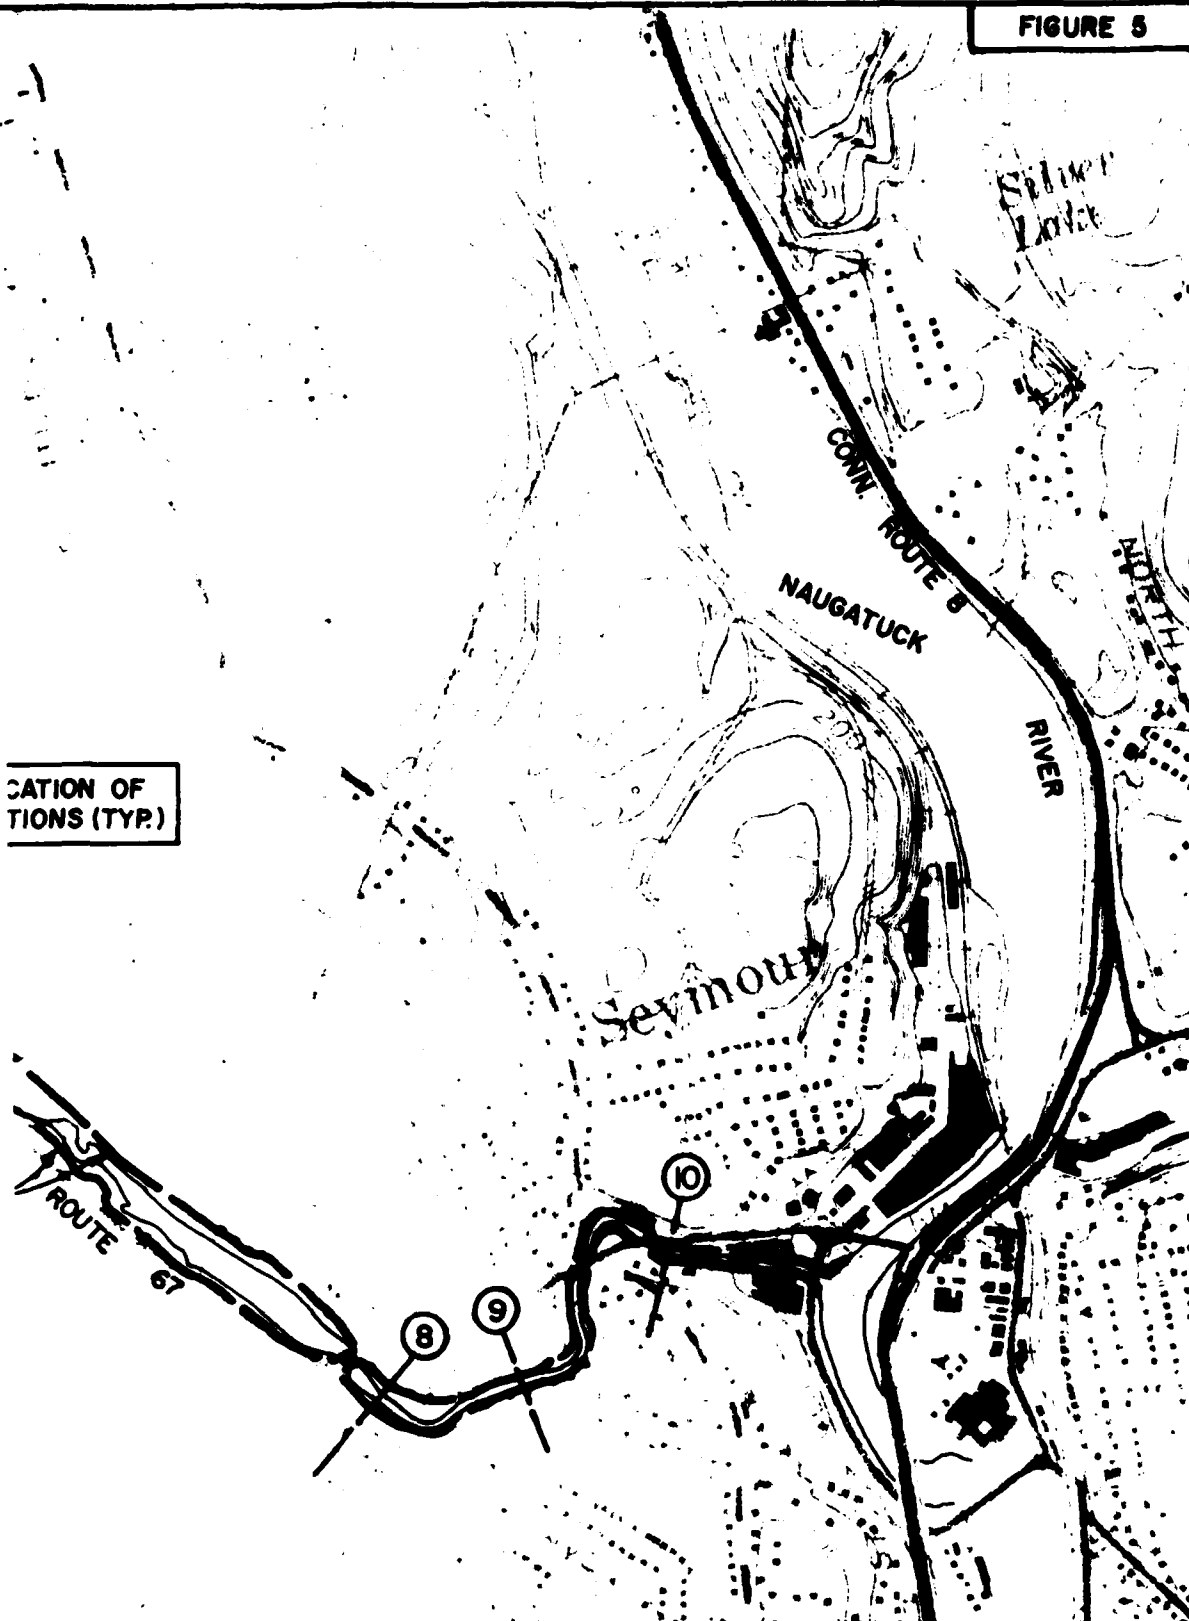
FIGURE 5

The maximum spillway discharge of 245 cfs prior to dam failure would be contained within the existing river channel. The flood wave due to dam breach would flood houses up to 8 feet above sill elevation. Increases in depth of flow due to the dam breach range from 15 feet at section 3 to about 5 feet at section 10 (See Figure 5, page D-39).

The maximum spillway flow of about 245 cfs prior to dam failure would be contained within the existing river channel. Increases in depth of flow due to the dam breach would range from 15 feet at section 3 to about 5 feet at section 10. (See Figure 5, page D-39.)
